Borough of Wilkinsburg

Wilkinsburg Borough is hereby soliciting bids for masonry repairs to the entire exterior of the Borough Building located at 605 Ross Avenue, Wilkinsburg, PA. The Contractor will be responsible for completing all work outlined in this project specification.

Bid Specs Addendum

This is an addendum to the request for proposals for the 605 Ross Avenue exterior masonry repair project that was advertised on June 29, 2023. This addendum is a result of the pre-bid meeting held at 605 Ross Avenue at 10:00 a.m., July 10, 2023.

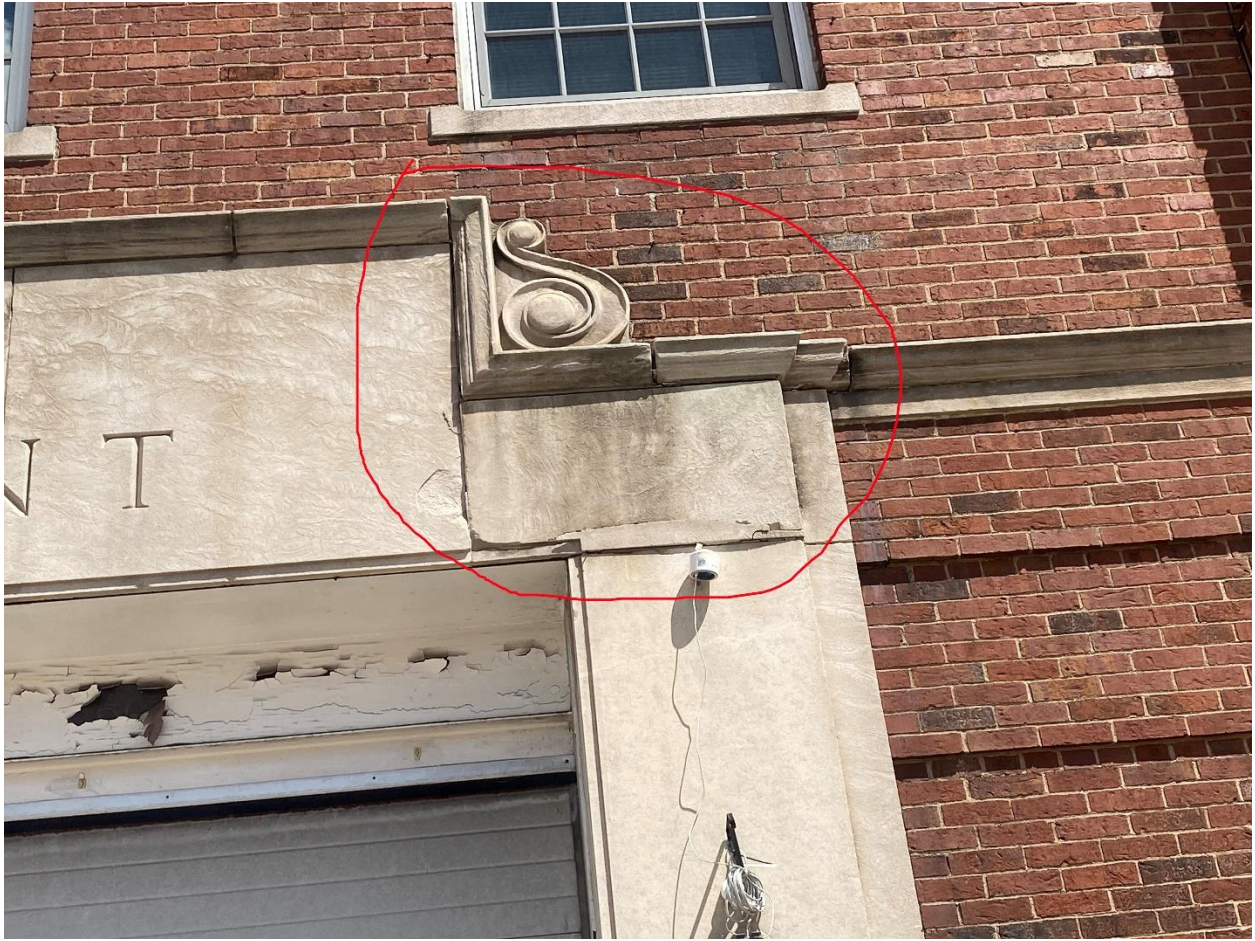
Image 1

- 10) Limestone replacement and repair
 - a. Replace two lower panels on left and right of front door
 - b. Upper right section above fire department garage door: Remove panels indicated in *Image 1*. Treat underlying steel, install flashing, install new concrete panels.

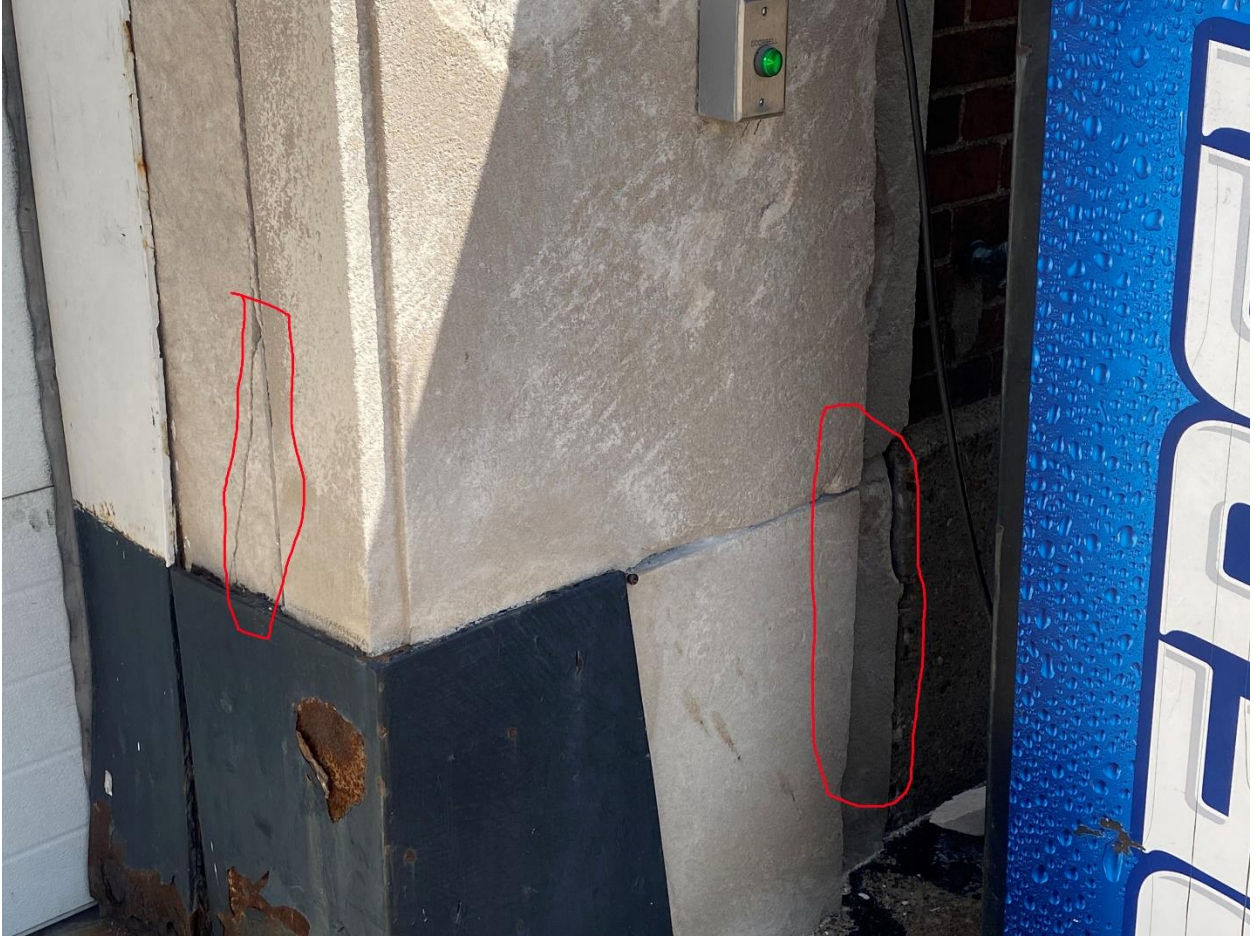
Image 2

- c. Lower right of fire department garage door, *image2*: patch from seam to seam, all damaged areas; remove and repair areas circled in red.
 - d. Lower left of fire department garage door: patch damaged surface.
